3-3-81  
REPORT NO. NADC-77073-30

## REAL-TIME X-RAY INSPECTION OF COMPOSITE AIRCRAFT STRUCTURES

December 1978

FINAL REPORT  
AIRTASK No. OTR Rework  
Work Unit No. GA801

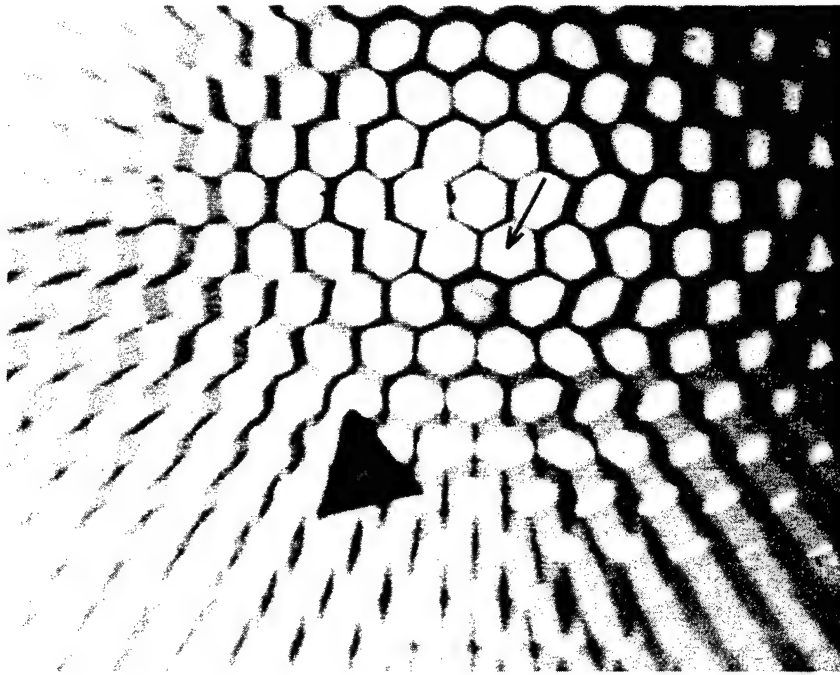
Another common type of composite defect listed on Table 6 is core damage. This can either occur during manufacturing or result from impact or ballistic damage. Figure 13 shows an RTR of a graphite/epoxy sample with a single damaged cell resulting from manufacturing. Another example, Fig. 14, is an RTR of a graphite/epoxy sample with the honeycomb core damaged by impact. These examples illustrate the sensitivity of RTR for detection of core damage even as minute as damage to a single cell.

Figure 13. RTR of a Graphite/Epoxy sample with aluminum honeycomb illustrating damage in a singular core (70kV, 5mA)

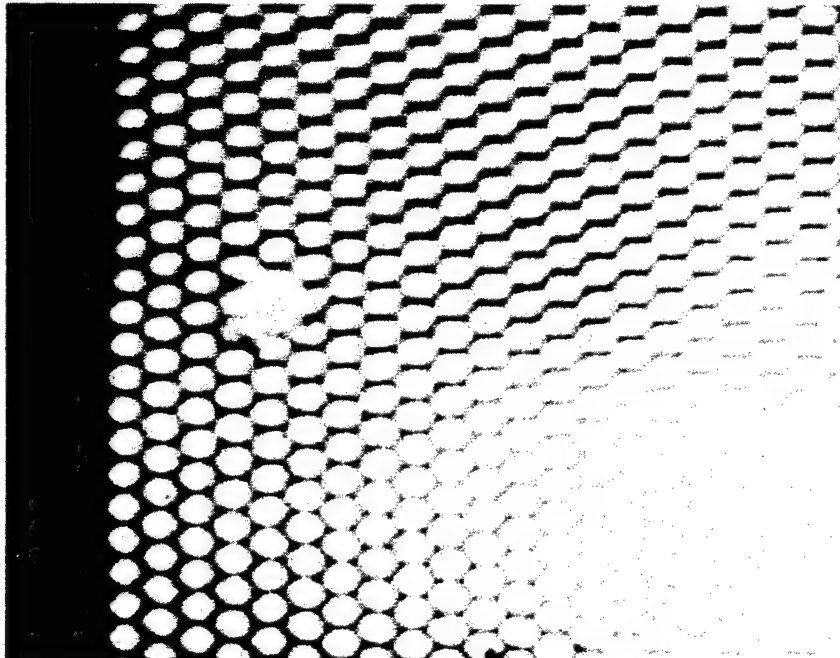
Figure 14. RTR of a Graphite /Epoxy Sample with Aluminum Honeycomb illustrating core damage (70kV, 5mA)

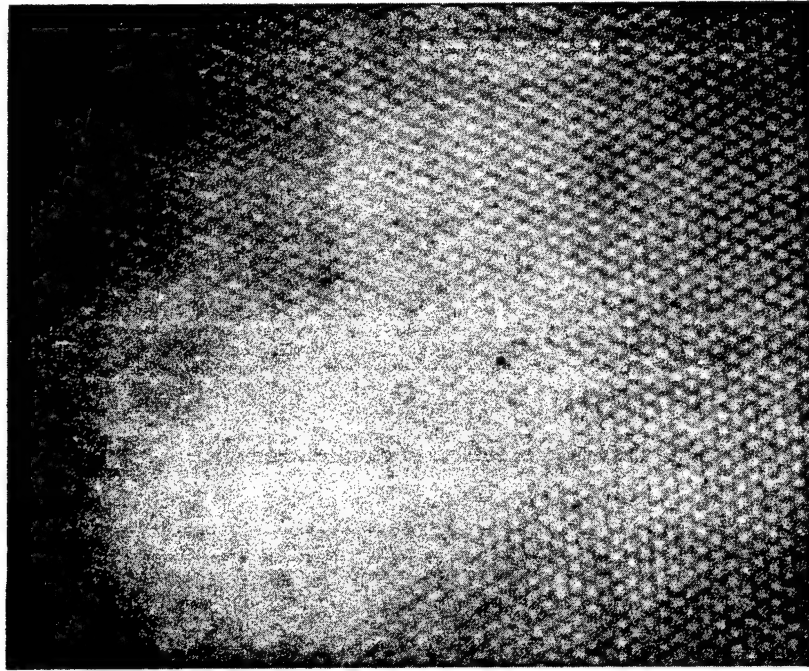
Figure 15. RTR of a Graphite/Epoxy sample with composite honeycomb illustrating moisture absorption throughout the sample (70kV, 5mA)

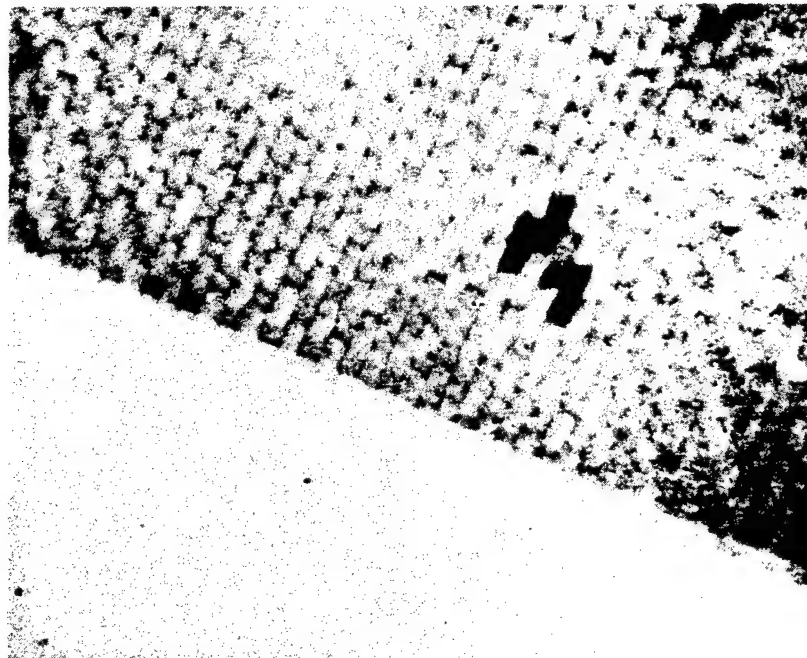
Figure 16. RTR of a Fiberglass/Epoxy sample illustrating water-filled cores in the honeycomb (70kV, 5mA)

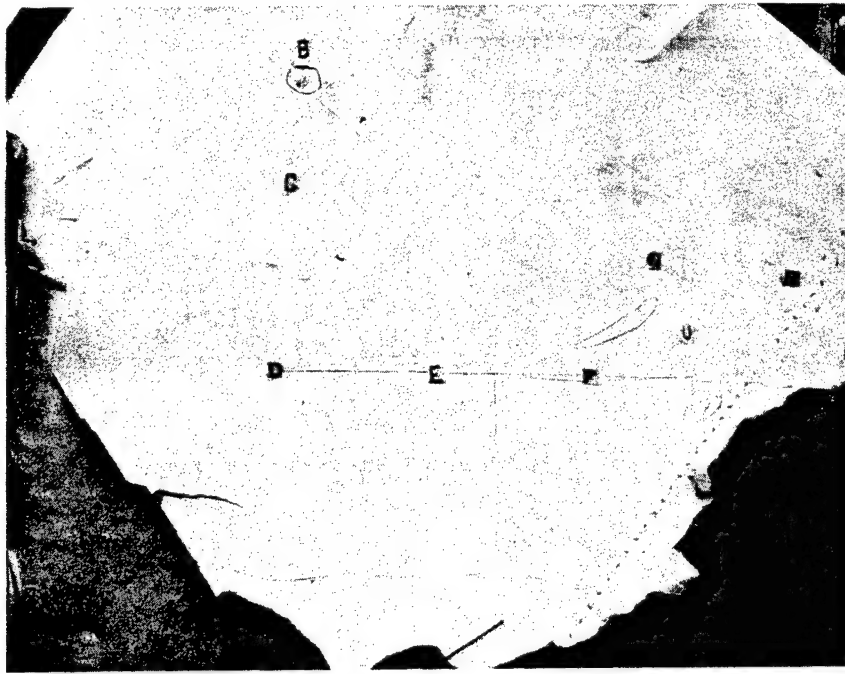
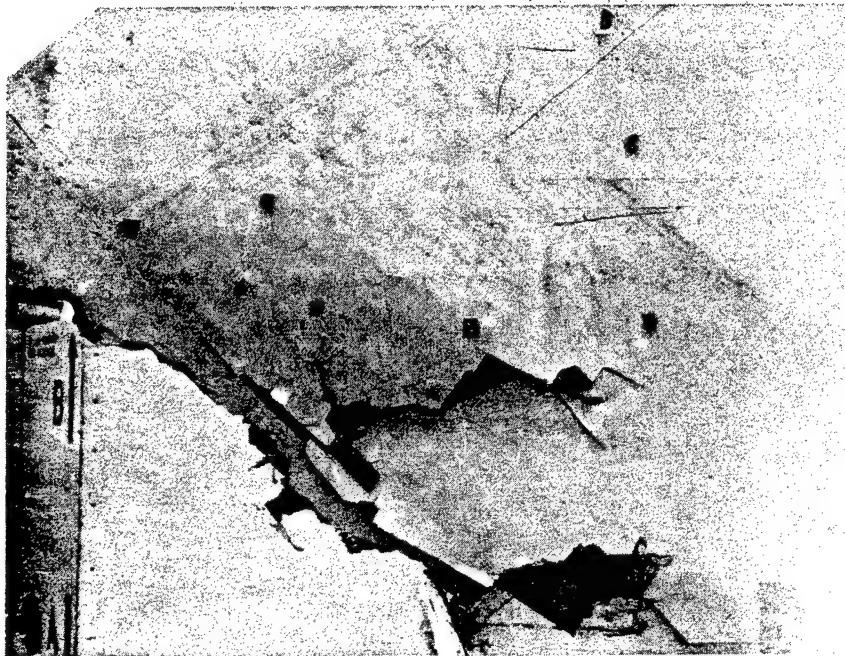
Figures 17 and 18 show the front (x-ray source side) and back (next to RTR screen) of a damaged F-14 stabilizer labelled with lead letters at different areas to identify the area during inspection. The photographs illustrate extensive damage at D, E and F, with no visible damage at C, H and U. Areas B and G contain small nicks that are visible on the surface.

Figure 17. Front Side of a damaged F-14 Boron/Epoxy horizontal stabilizer

Figure 18. Back side of the F-14 horizontal stabilizer

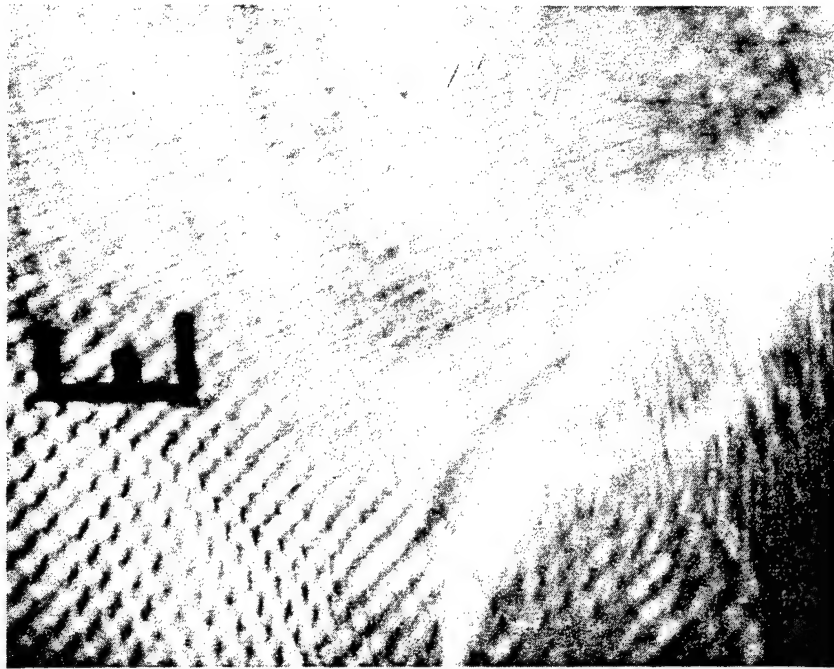
Figures 19, 20 and 21 are the RTR's of areas D, E and F illustrating the extensive skin and honeycomb damage. Figures 19 and 20 of areas E and F indicate extensive core damage and various cracks (light areas). In addition, area D, Fig. 21, illustrates single cell damage similar to the damaged cell produced during manufacturing (Fig. 13). Area U is shown in Fig. 22, with varying amounts of damage indicated in the upper right quadrant. Areas B and G that contained the nicks were inspected, with the small nick at B barely visible on the videomonitor. Although the nick at area G could be seen on the monitor, it was impossible to photograph. The last area, H, was radiographed to show where the composite and metal are bonded. Figure 23, of the area shows the variations in the adhesive bonding the honeycomb structure to the aluminum. Figure 24, another RTR of area H, is a radiograph taken with increased x-ray energy and current to image the metallic area which is not very visible

Figure 19. RTR of area E of F-14 stabilizer illustrating the excessive honeycomb damage and cracks (65kV, 3.5mA)

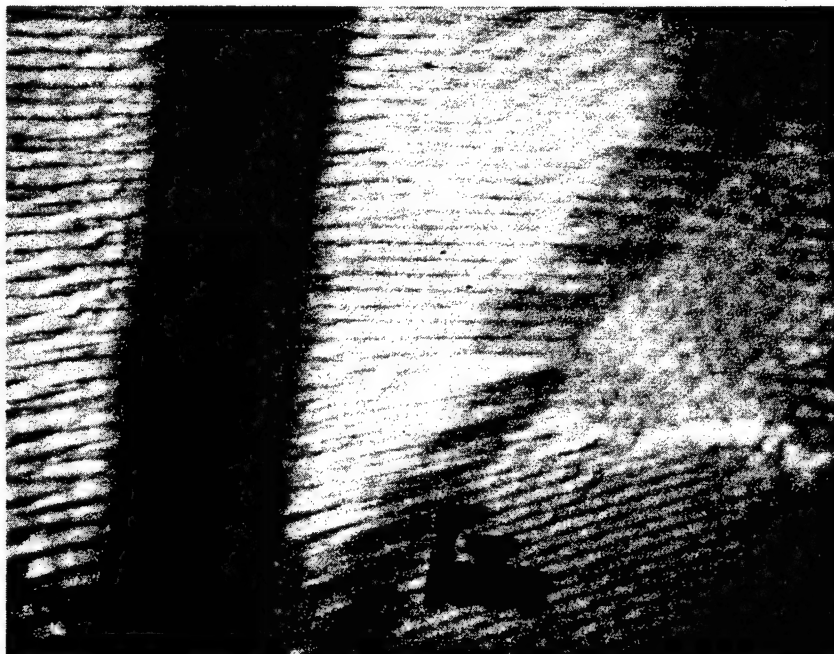
Figure 20. RTR of area F of F-14 stabilizer illustrating a large crack (indicated by the light area) (65kV, 3.5mA)

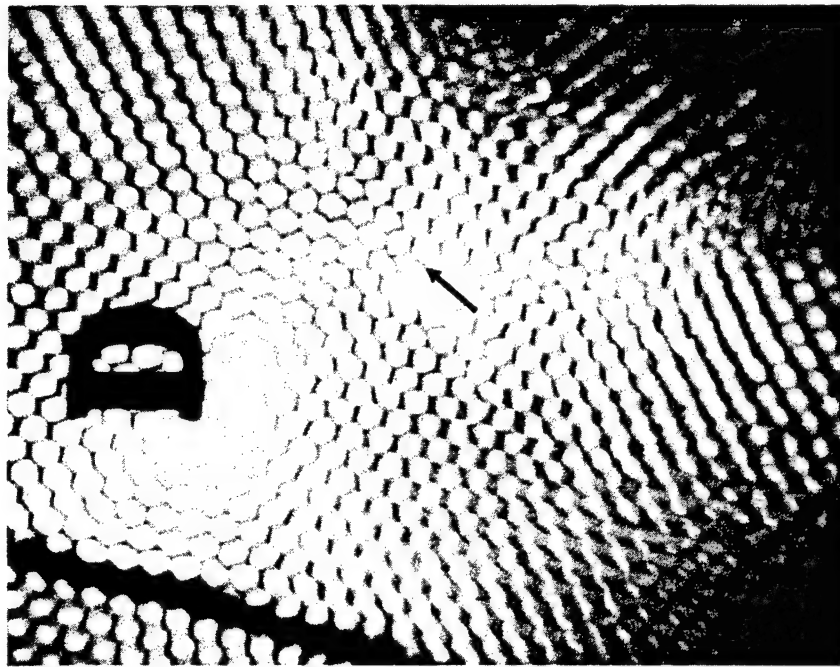
Figure 21. RTR of area D illustrating a large area of crushed honeycomb in the right corner. In addition a singular core indicates core damage similar to the type in Figure 13. (65kV, 4mA)

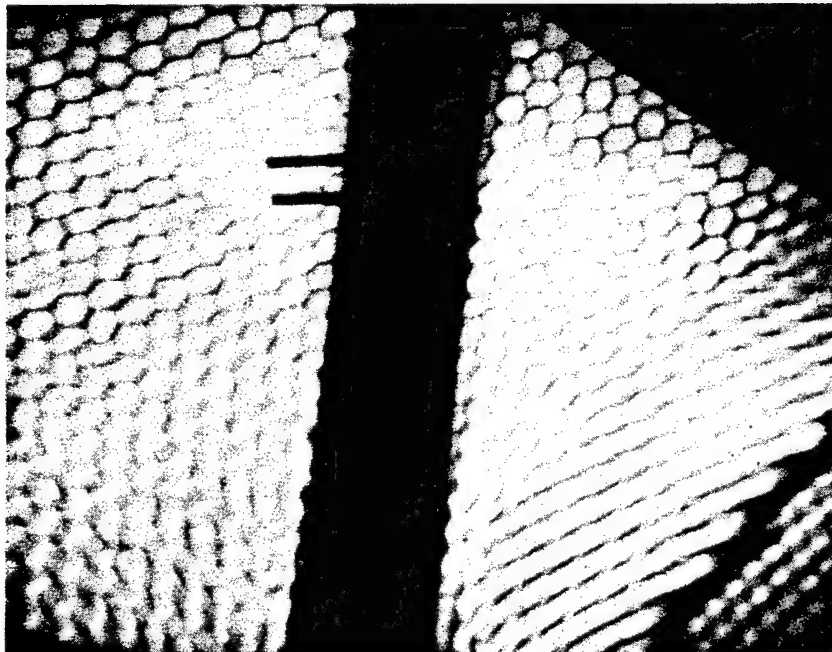
Figure 22. RTR of area U illustrating damage that is not visible on the surface (64kV, 4mA)

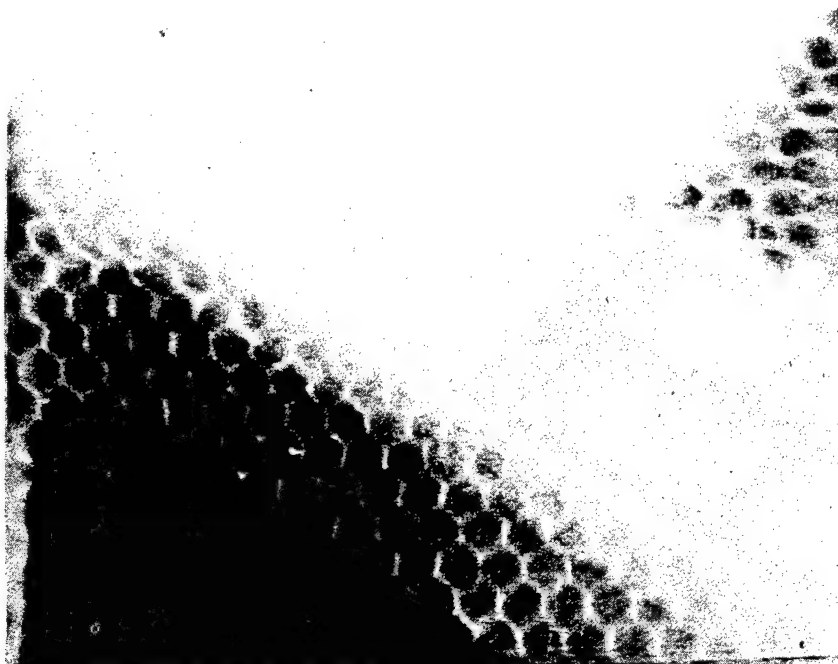
Figure 23. RTR of area H illustrating where the honeycomb is bonded to the aluminum honeycomb. The white areas indicate excessive adhesive (80kV, 4mA)

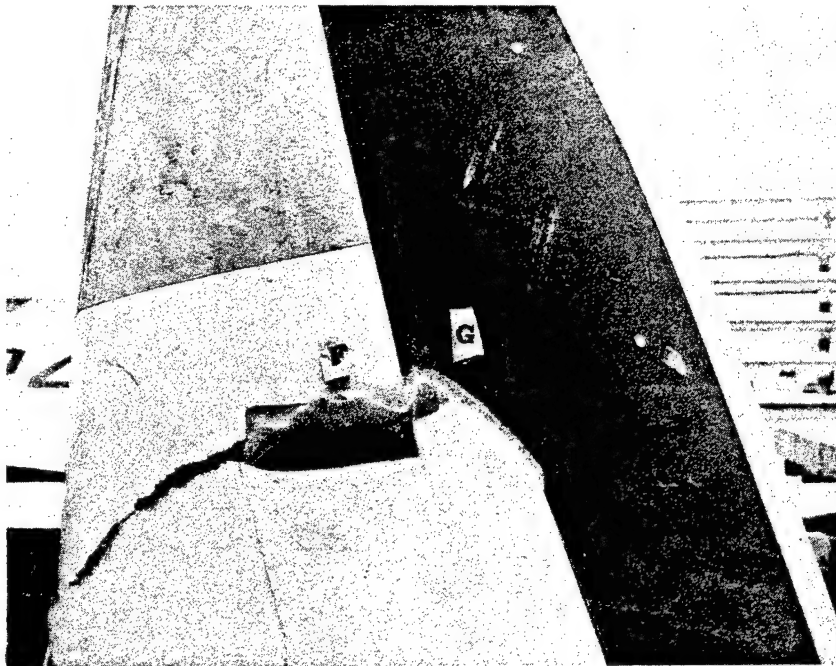
Figure 25. Damaged Fiberglass/Epoxy F-14 Radome containing a fiberglass honeycomb core

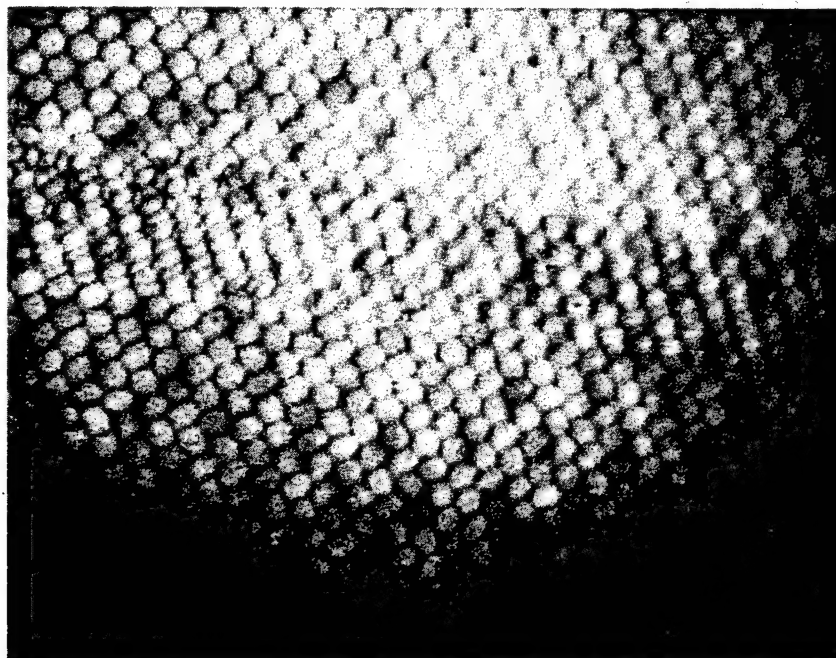
Figure 26. RTR of area F of the F-14 radome illustrating the cracks (white areas) and damaged honeycomb. The variations in the RTR indicate the porosity in the honeycomb. (60kV, 3.6mA)

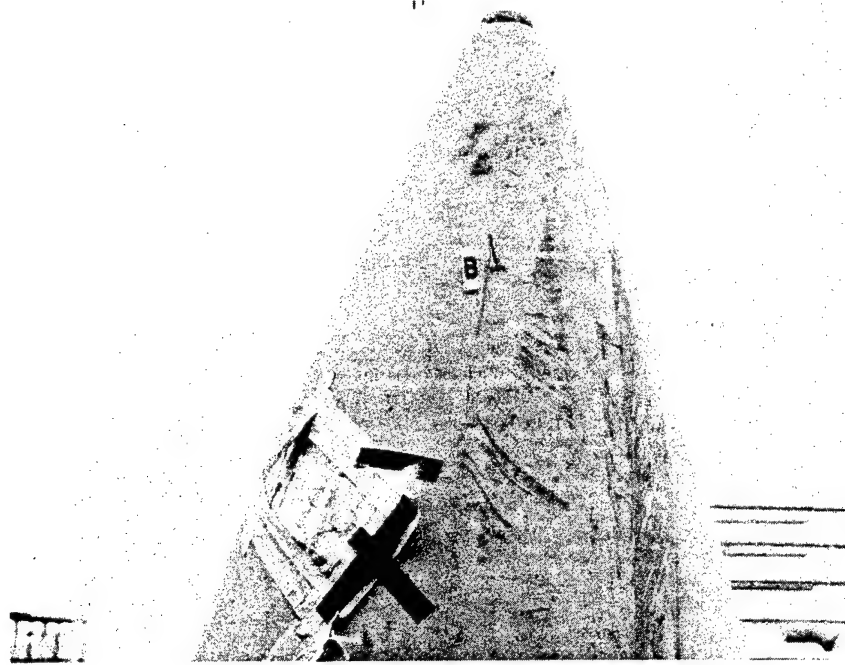
Figure 27. Damaged F-14 radome with a nick visible at area B

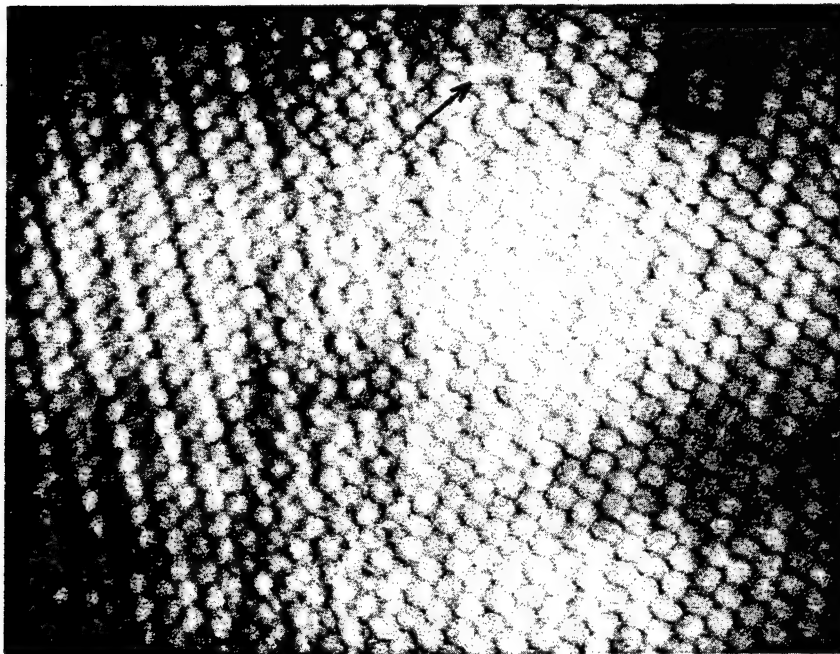
Figure 28. RTR of area B of F-14 radome illustrating the nick (60kV, 3.6mA)

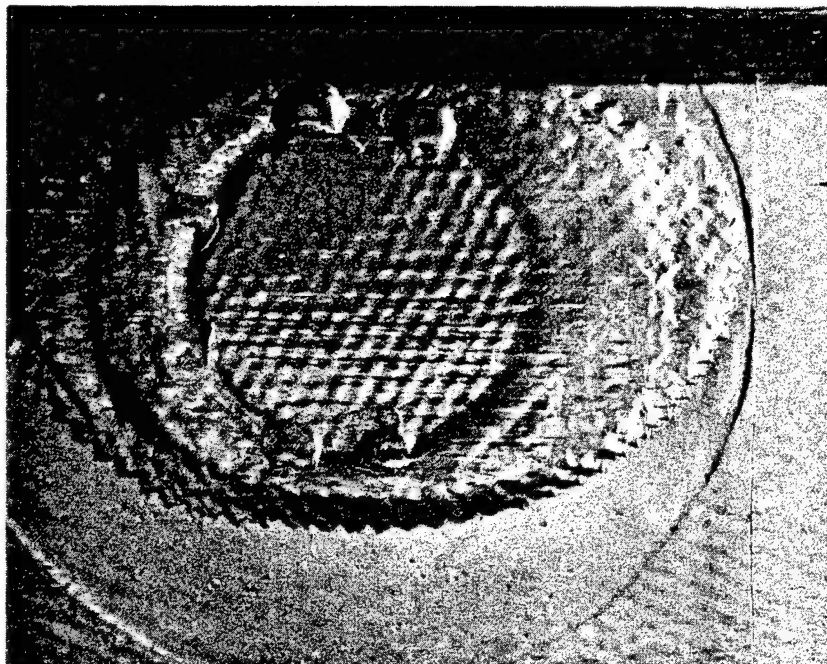
The last example inspected by direct RTR imaging was not for defects or damage, but repair verification. An S-3A spoiler recently repaired by the NARF, Alameda and NADC, Warminster was inspected at SAI to illustrate the feasibility of real-time radiography to image the repaired area and to inspect the splice of the core plug and also the core filter. Fig. 29 shows the repaired area of the graphite/epoxy S-3A spoiler. The RTR, Fig. 30, clearly illustrates the splice, plug, and filler. This radiograph illustrates another feature of the RTR system; the ability to electronically enlarge the image on the videomonitor. This was very advantageous when inspecting the splice and was shown to be superior to film radiographs, because of the ease of viewing the area. Therefore, utilization of RTR for this application would allow inspection to immediately verify the condition of the repair.

Figure 29. Repaired area of an S-3A graphite/epoxy spoiler

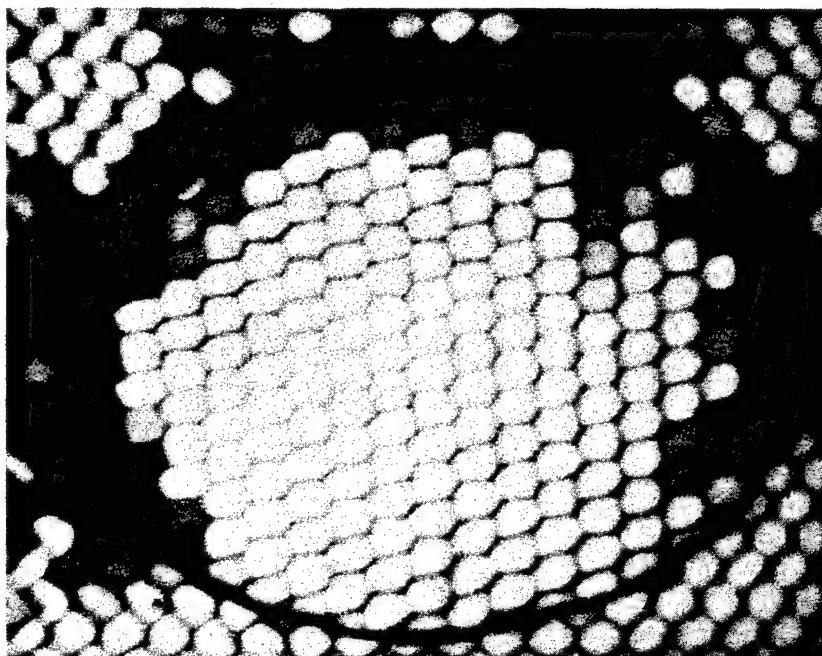
Figure 30. RTR of repaired area illustrating splice and filled core (70kV, 5mA)

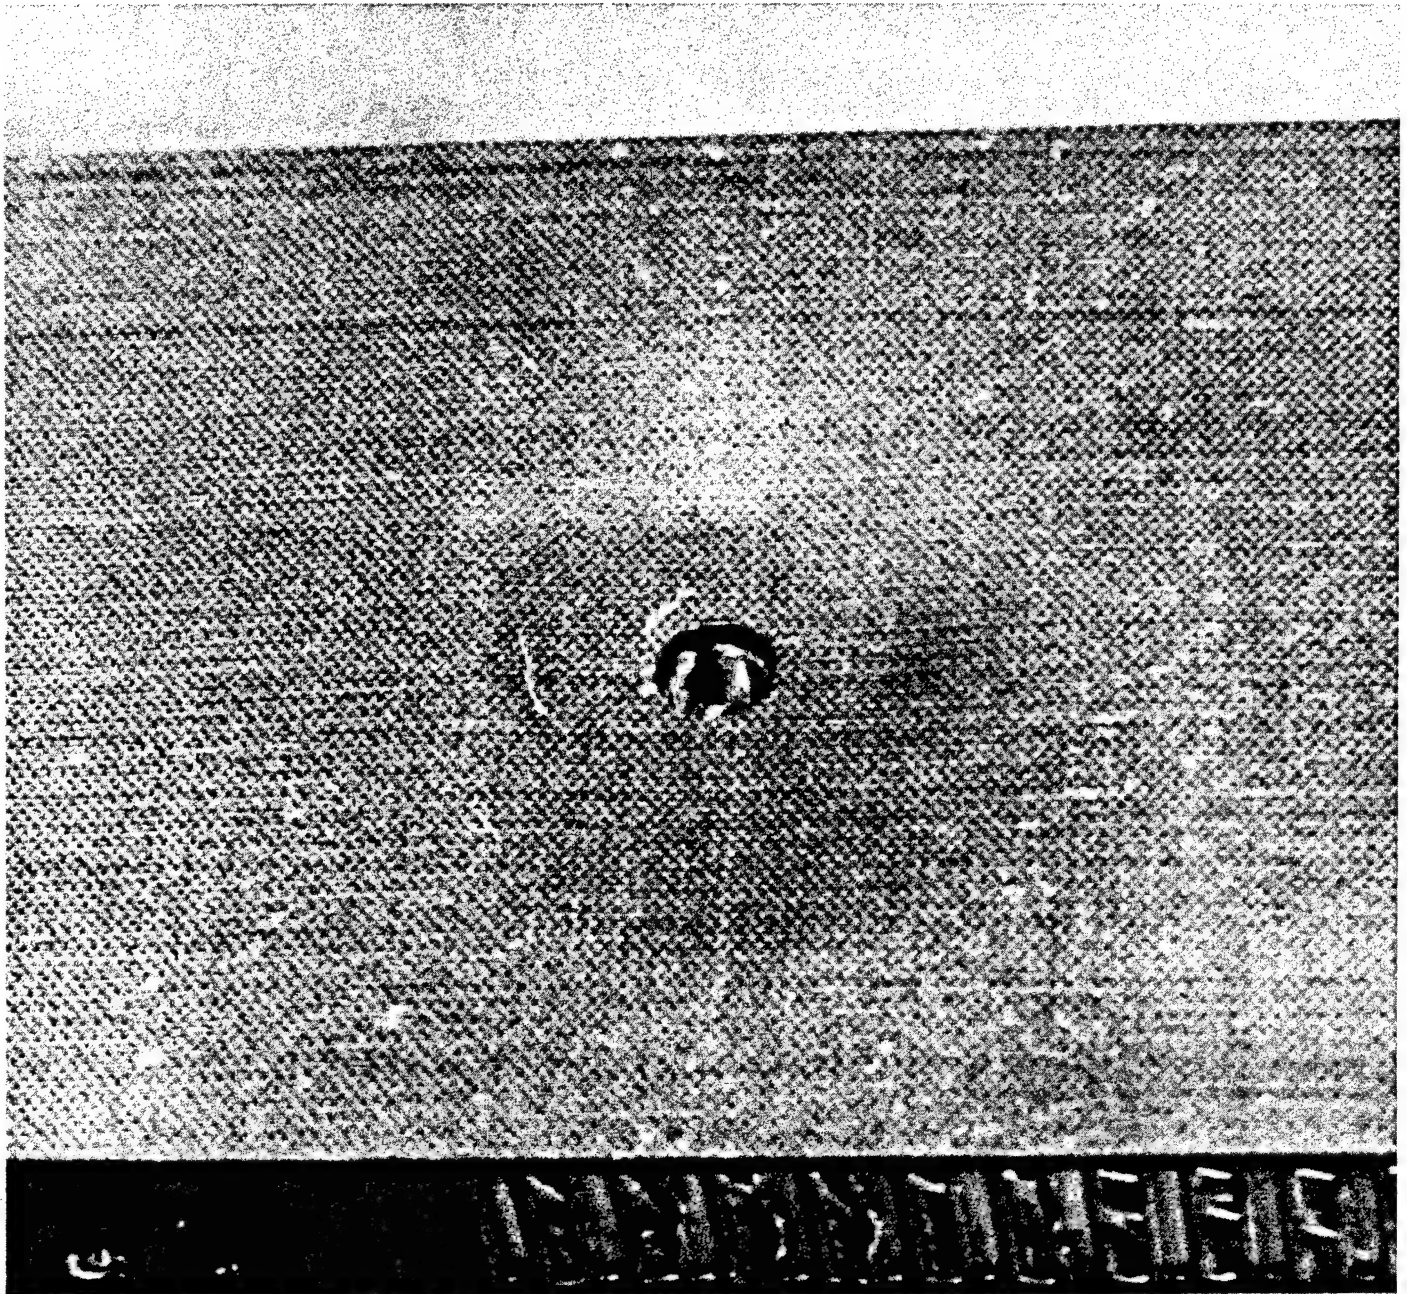
The first sample tested with the system is shown in Fig. 37. This is a graphite/epoxy sample with aluminum honeycomb that was hit with a hammer to produce debonds and delaminations. A 1/4 inch hole was then drilled and the penetrant was forced into the area. Figure 38, the RTR, shows where the liquid has flowed throughout the area illustrating debonds or delaminations. The next RTR, Fig. 39, shows an electronic video enlargement of the same area, showing areas where the liquid is not in the honeycomb, thus indicating that the liquid has flowed in between the graphite/epoxy layers.

Figure 37. Photograph of a section of a Graphite/Epoxy sample with aluminum honeycomb. It has been damaged by hitting the area with a hammer. A  $\frac{1}{4}$  inch hole has been drilled for the injector tip.

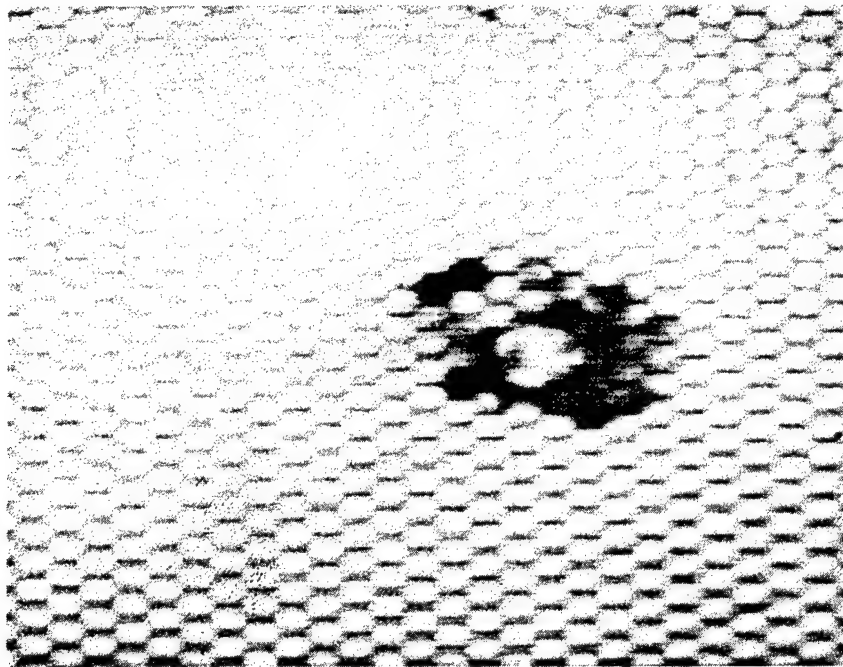
Figure 38. RTR of the damaged area illustrating where the penetrant has flowed into the honeycomb and possibly between the laminations indicating debonds and delaminations (65kV, 5mA)

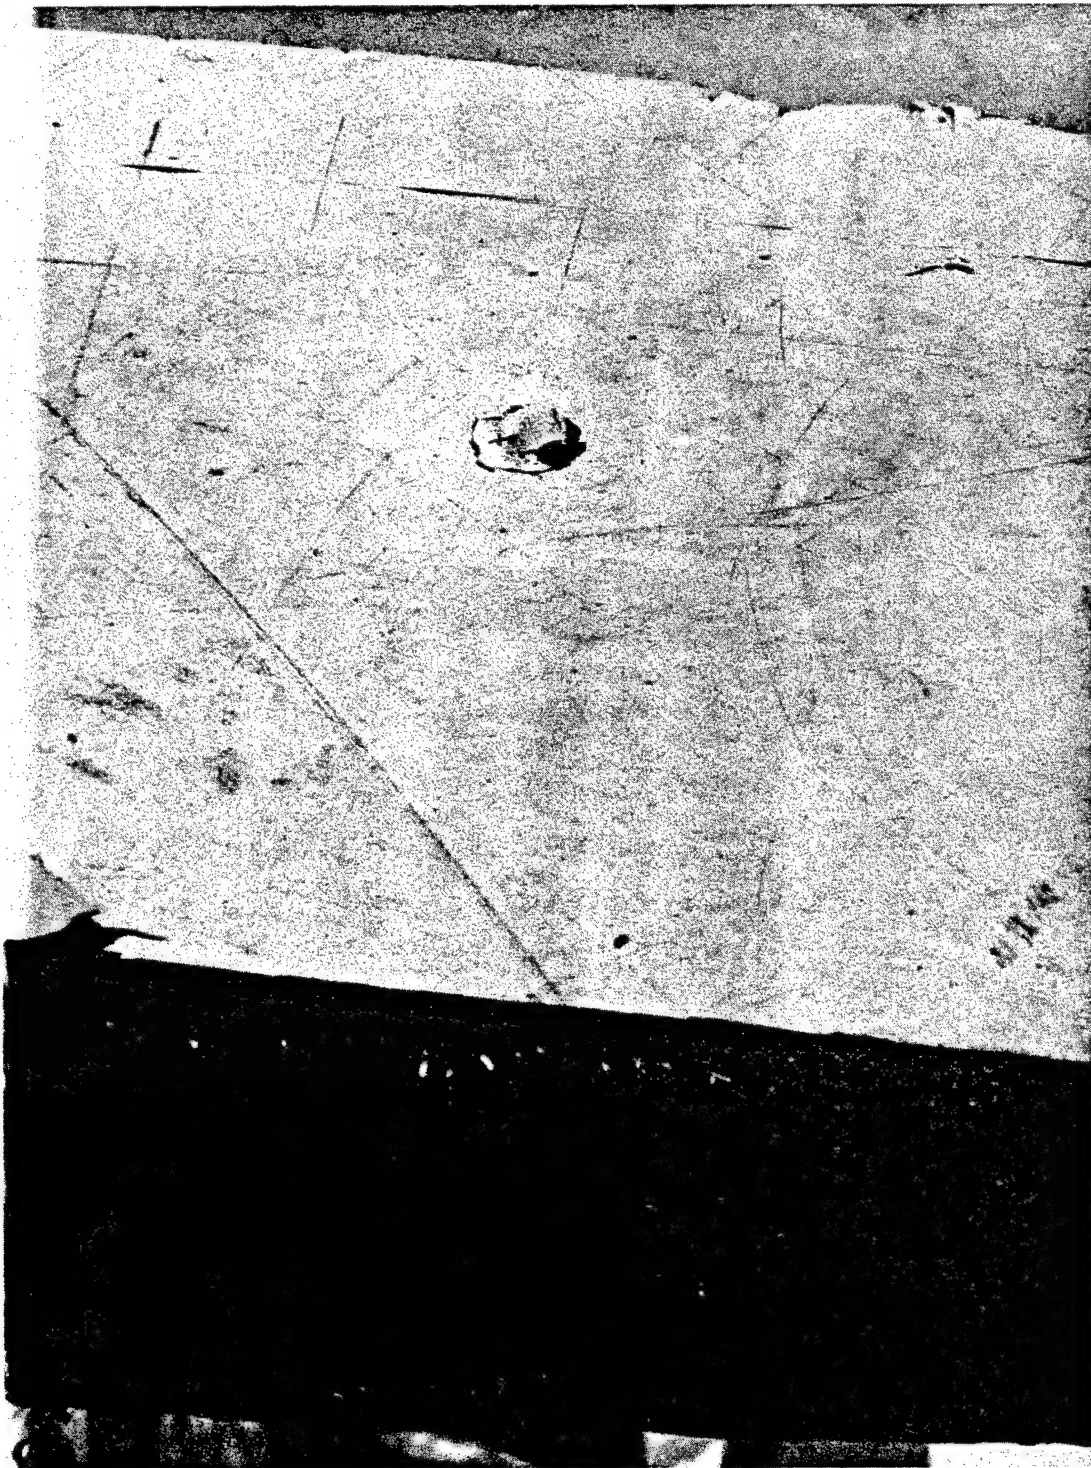
Another sample, a piece of an F-14 boron/epoxy horizontal stabilizer, Fig. 40 was hit with a hammer and injected with the penetrant to determine the extent of the damage. Figure 41 is an RTR of the area showing that there is no apparent physical damage to the structure. The light area in the radiograph is the 1/4 inch drilled hole. Figure 42, the RTR of the area with the penetrant, illustrates that the liquid has flowed throughout a much larger area than indicated by

Figure 40. Photograph of a small damaged area with a  $\frac{1}{4}$  inch drilled hole for the injector tip. This is a F-14 Boron/Epoxy horizontal stabilizer section.

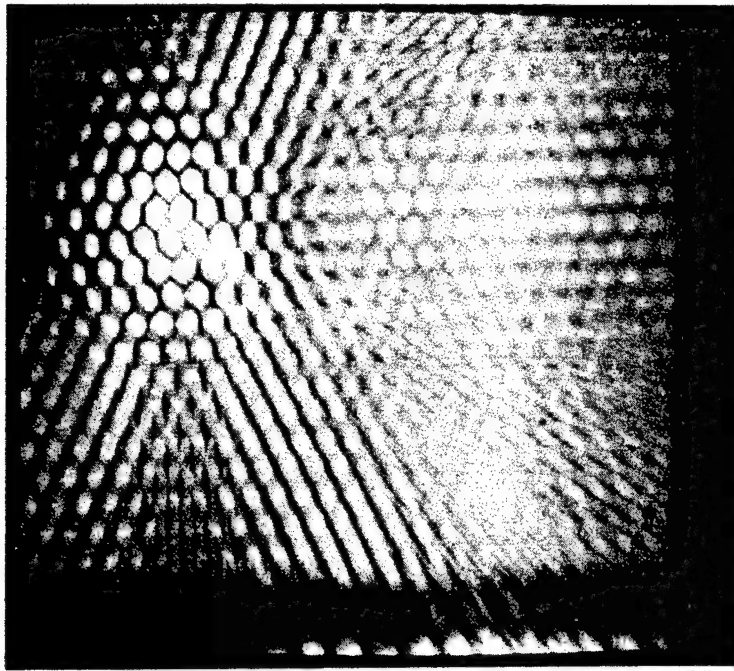
Figure 41. RTR of the damaged section, with no visible indication of damage. The light area is the  $\frac{1}{4}$  inch drilled hole (65kV, 5mA)

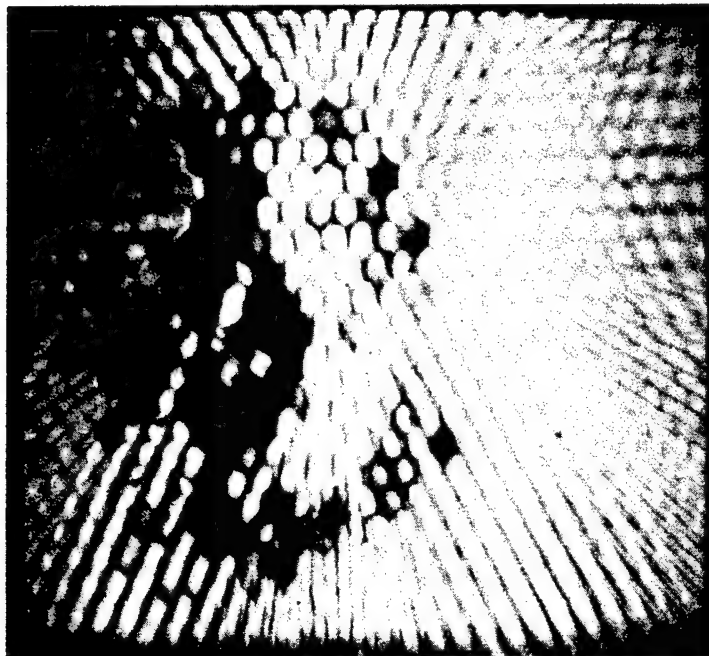
Figure 42. RTR of damaged area illustrating where the penetrant has flowed throughout the piece. This indicates fairly excessive damage for relatively small surface damage (65kV, 5mA)

the surface damage. The radiograph shows that the penetrant has filled many honeycomb cores, indicating debonds; but it is very difficult to determine if there are any delaminations between the boron/epoxy layers.

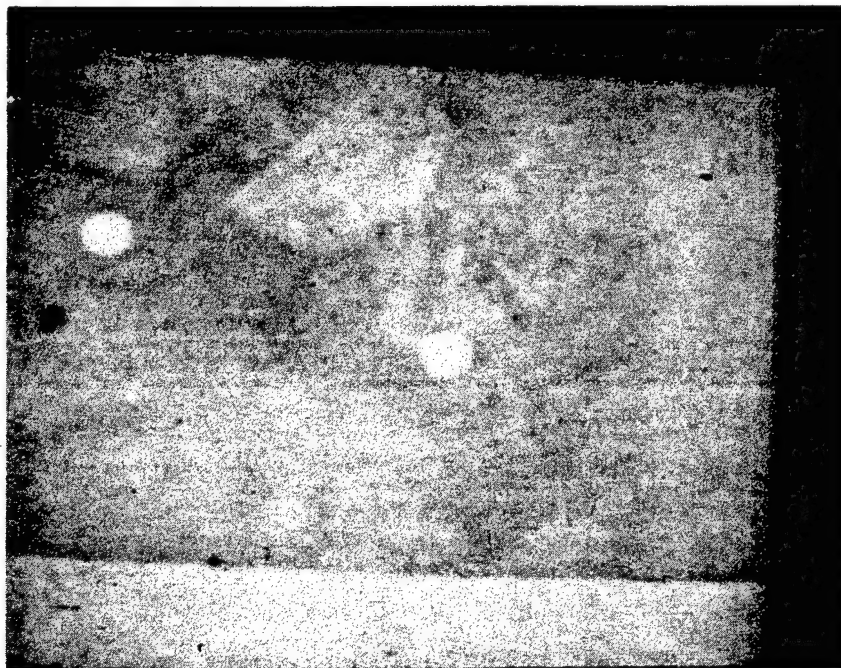
Figure 44. RTR of areas illustrating where the liquid has flowed into the delaminations (65kV, 5mA)

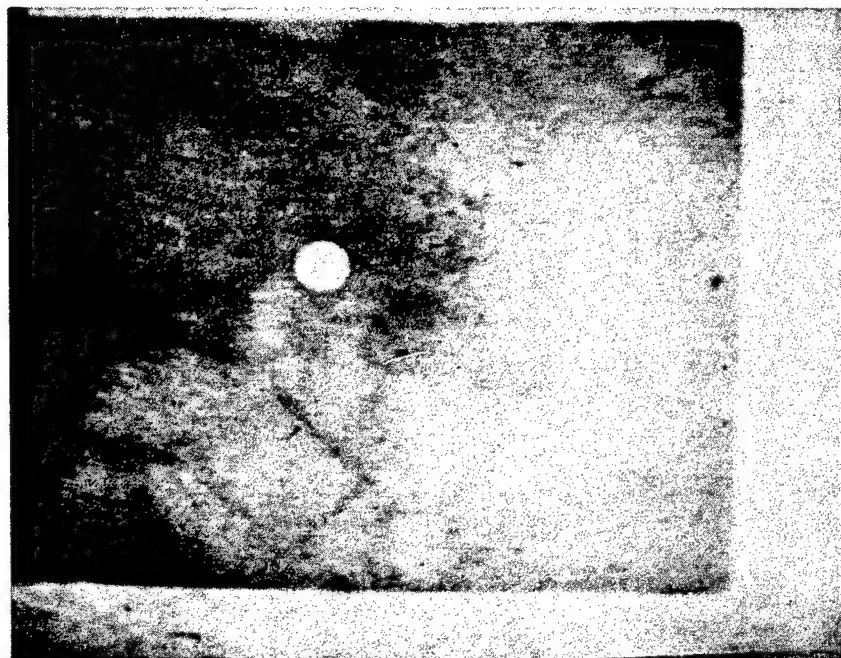
Figure 45. RTR illustrating excessive delaminations throughout the area, indicated by the large amount of the penetrant in the area (65kV, 5mA)
